**Government of Maharashtra  
Water Resources Department**

**Annual Consolidated Health Status Report of  
Identified Large Dams in  
Pune Region (Year 2019-20)**

**Superintending Engineer,  
Dam Safety Organization,  
CDO Building, Dindori Road, Nashik- 422004**

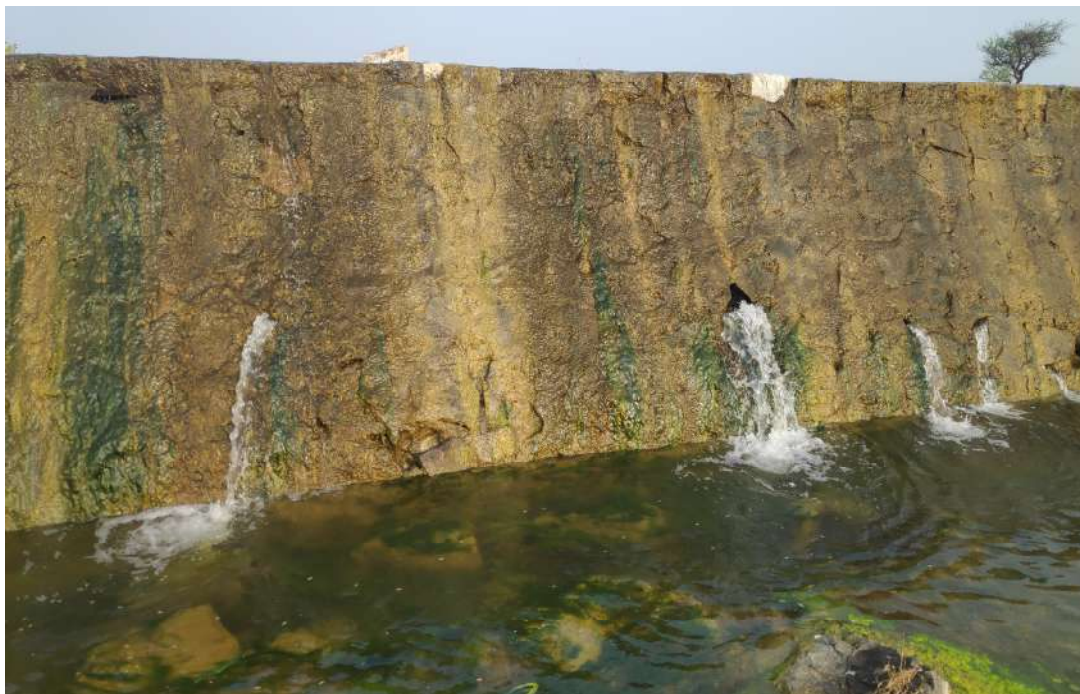
Name of Dam-Kankatrewadi  
Class-2 Dam  
Taluka-Khatav, Dist-Satara  
Defeciency-Leakage through W.W.Bar  
Date-20.11.2019

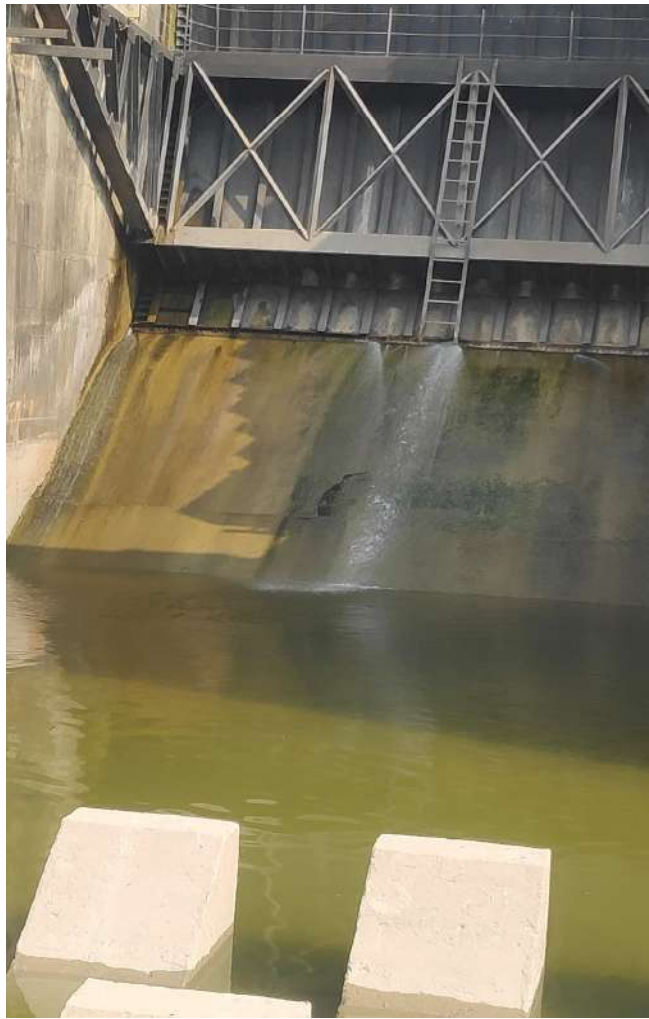
Name of Dam-Ghod  
Class-1 Dam  
Taluka-Shirur, Dist-Pune  
Deficiency-Leakage through Spillway gate  
Date-08.01.2020
