**Government of Maharashtra
Water Resources Department**

**Annual Consolidated Health Status Report
of Identified Large Dams In
Amravati Region (Year 2019-20)**

**Superintending Engineering
Dam Safety Organization,
CDO Building, Dindori Road, Nashik-4**

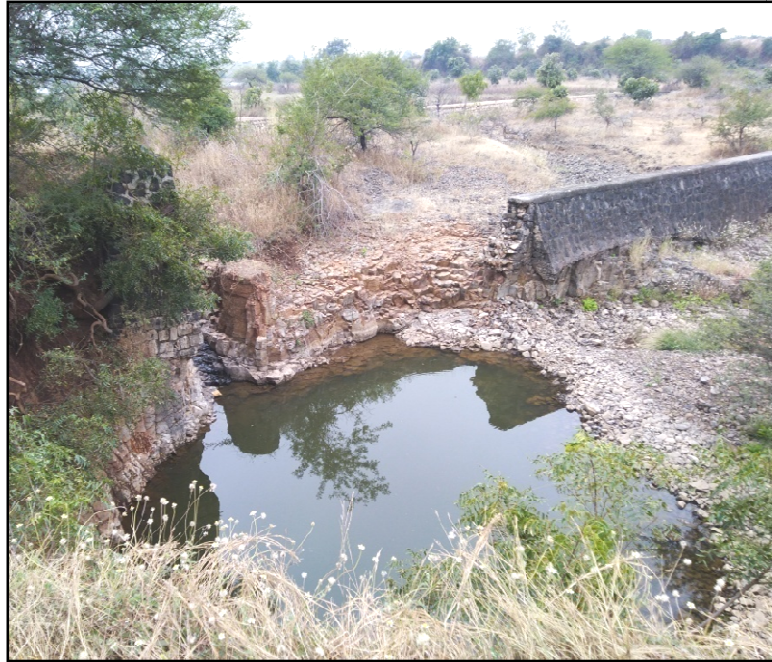
Photo -1

Pimpalgaon Chambhare (Class-II)
Taluka – Barshi takli Dist – Akola Date of Inspection –31/12/2019
Curtain wall @ RD 30m of 60m. Length is damaged. (B7)

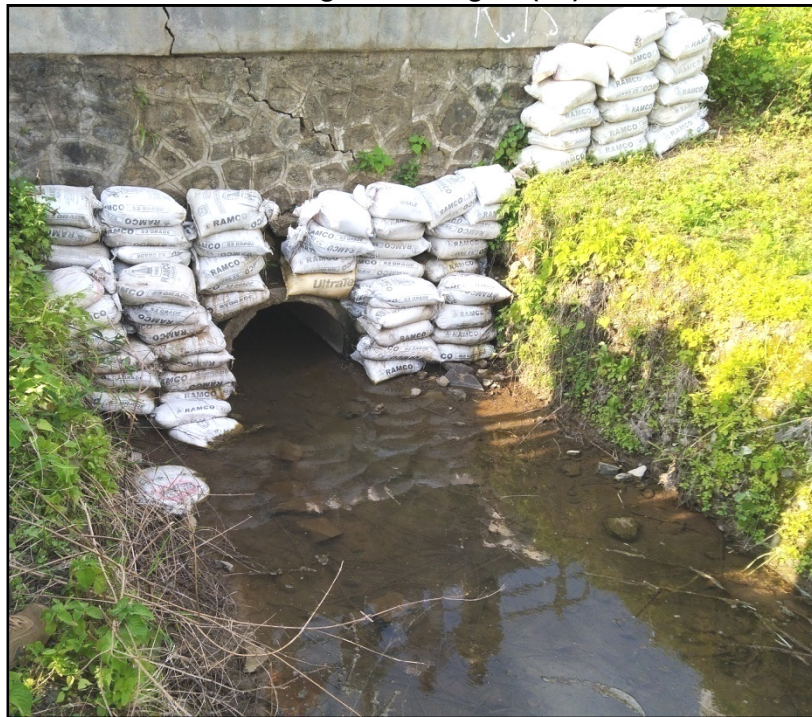
Photo 2

Masrul (Class-II)
Taluka – Buldana Dist – Buldana Date of Inspection –22/08/2019
Leakages at D/S head wall near outlet pipe is observed.(A4)
