**Government of Maharashtra
Water Resources Department**

**Annual Consolidated Health Status Report
of Identified Large Dams In
Nagpur Region (Year 2019-20)**

Totladoh Dam

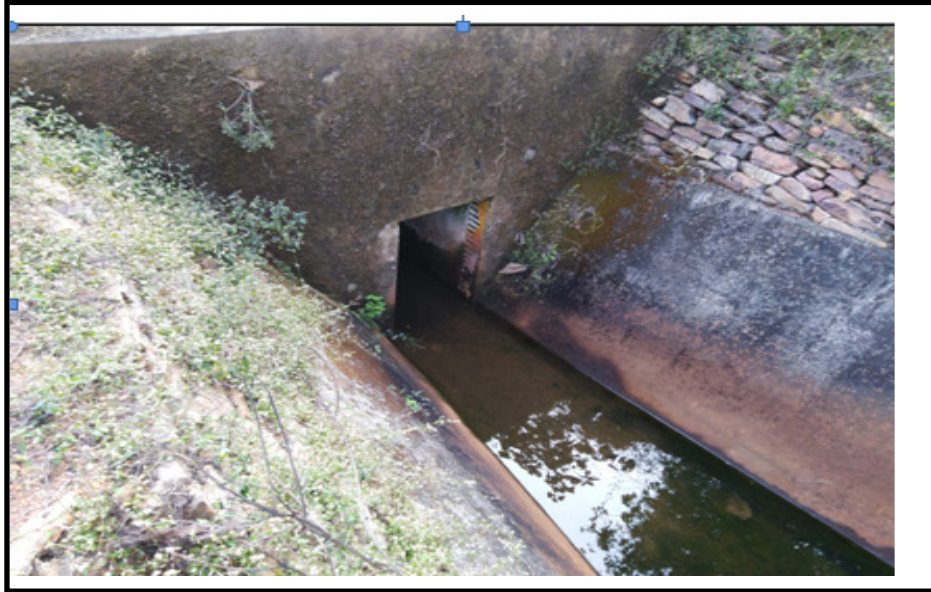
Photo -1

Risala Dam (Class-II)

Leakage in conduit from dam body. (A17) (Photo 1)

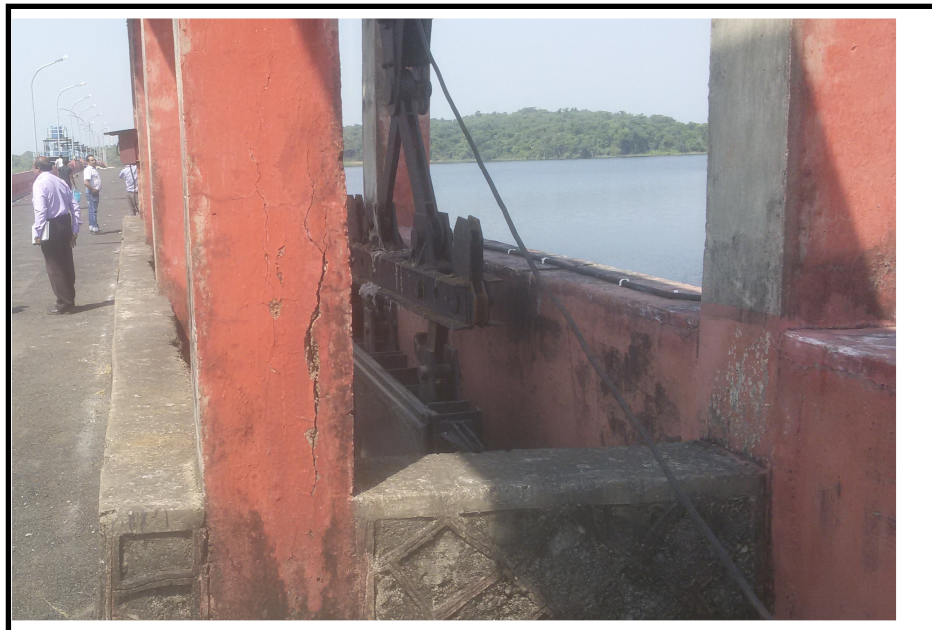
Photo 2

Erai Dam (Private Dam) (Class-I)
