**GOVERNMENT OF MAHARASHTRA  
WATER RESOURCES DEPARTMENT**

**Annual Consolidated Health Status  
Report of Identified Large Dams  
(Class-I,II) in Marathwada Region for  
Year 2019-20**

**Superintending Engineer  
Dam Safety Organisation,  
CDO Building, Dindori Road,  
Nashik-4**

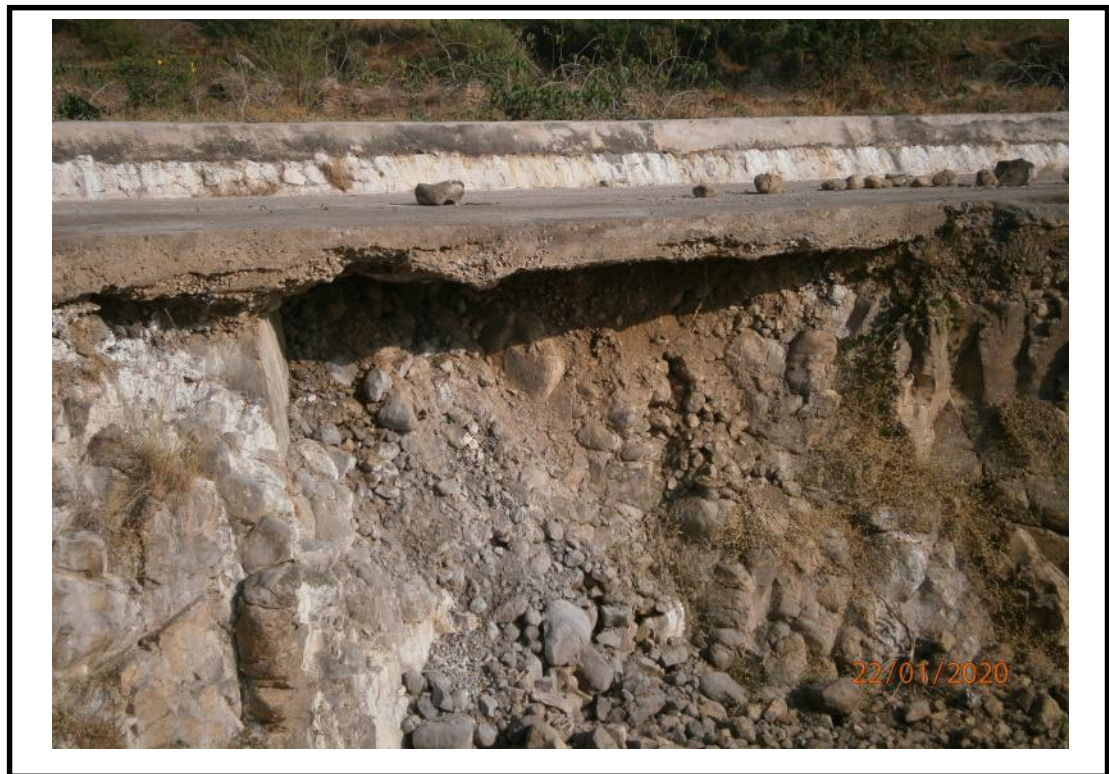
Photo -1

**Tintraj Dam (Class-II)**

**Date of Inspection – 22/01/2020**

**Heavy damages to tail channel & apron was noticed. (A7,A14)**

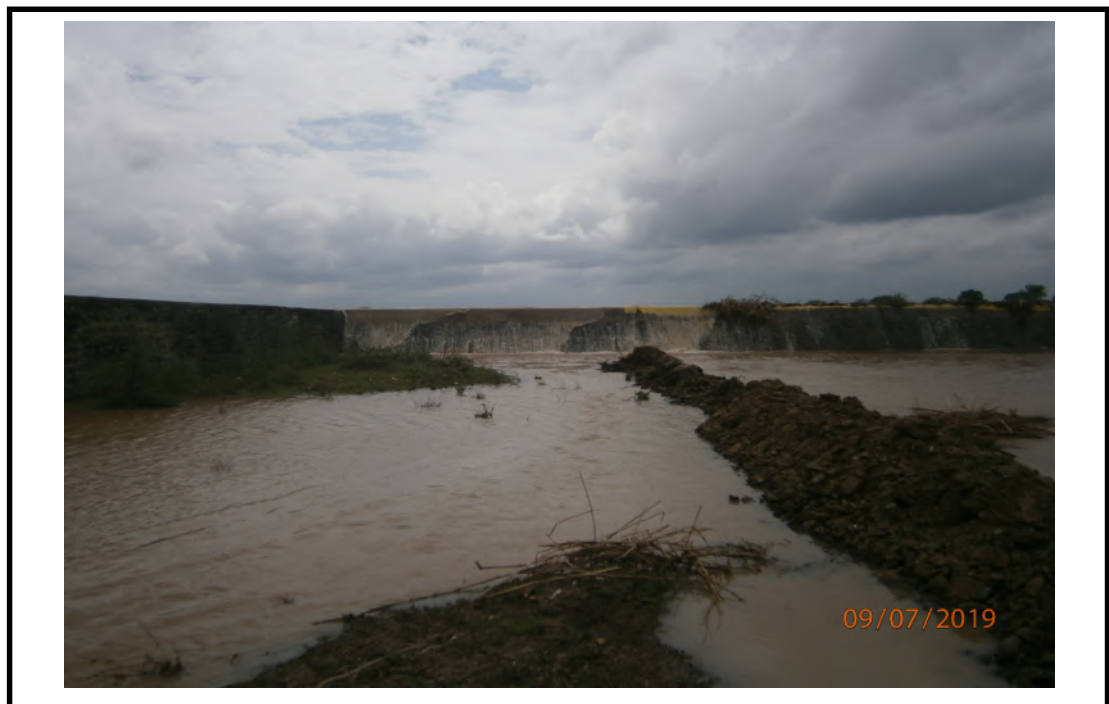
Photo 2

**Dhamna Dam (Class-I)**
