**GOVERNMENT OF MAHARASHTRA
WATER RESOURCES DEPARTMENT**

**Annual Consolidated Health Status Report of Identified Large
Dams (Class-I,II) in
North Maharashtra Region
for Year 2019-20**

Superintending Engineer,
Dam Safety Organization,
Dindori Road, Nashik- 4|

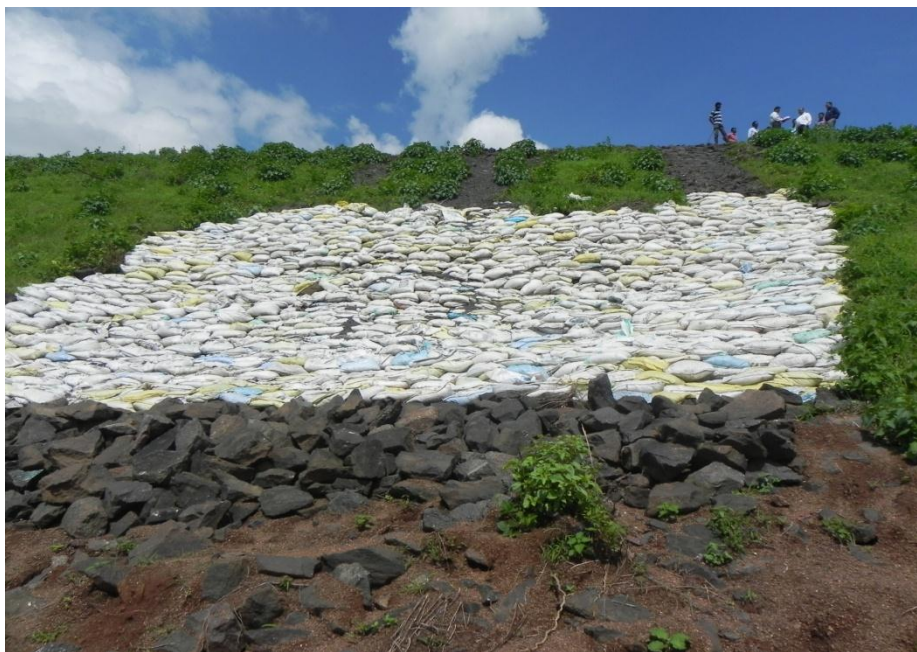
Photo-1

Inambari Dam (Class II)

Date of inspection:20/09/2019

Due to heavy rainfall during monsoon on the d/s slope of embankment portion having size approximately 20 x20 m and about 2 to 2.5 m deep is sleepped away with stone pitching.Rain water flowing under pitching may have eroded embankment.(B3)

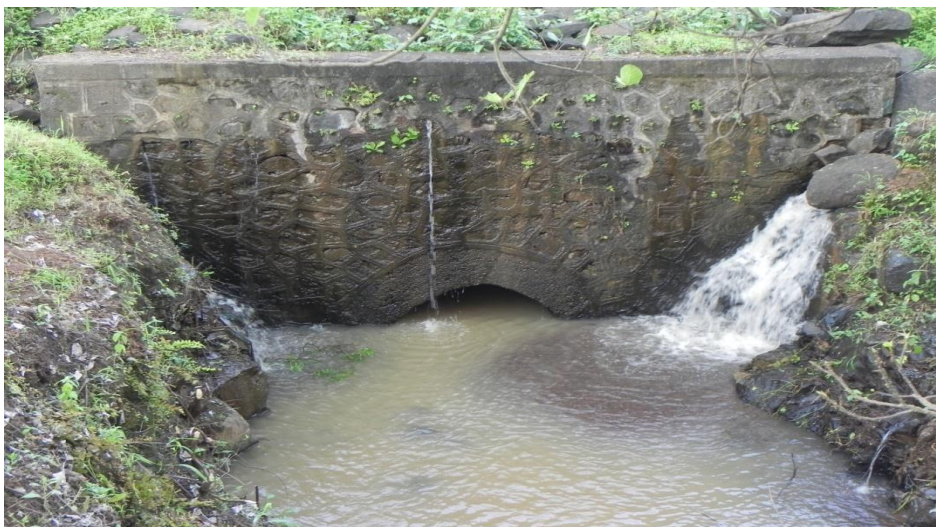
Photo-2

Aad Dam (Class II)
