**Government of Maharashtra  
Water Resources Department  
Annual Dam Health Status Report  
2021-22  
(North Maharashtra Region)**

**CHANKAPUR DAM**

**Superintending Engineer  
Dam Safety Organisation  
Nashik**

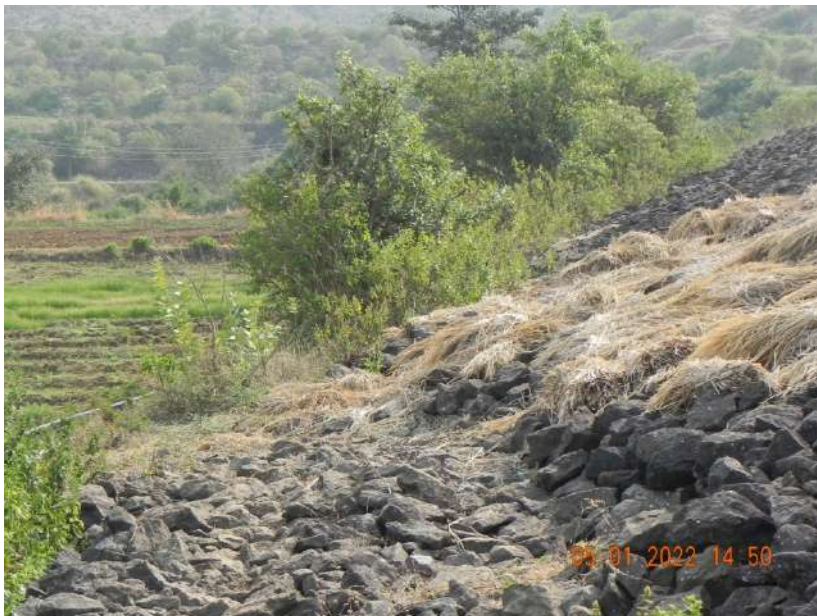
**Snapshot-1**  
**Bhegu Dam (Class I)**  
**Tal- Kalwan Dist-Nashik**  
**Date of inspection:05/01/2022**  
**Rock toe stone is disturbed.(B3)**

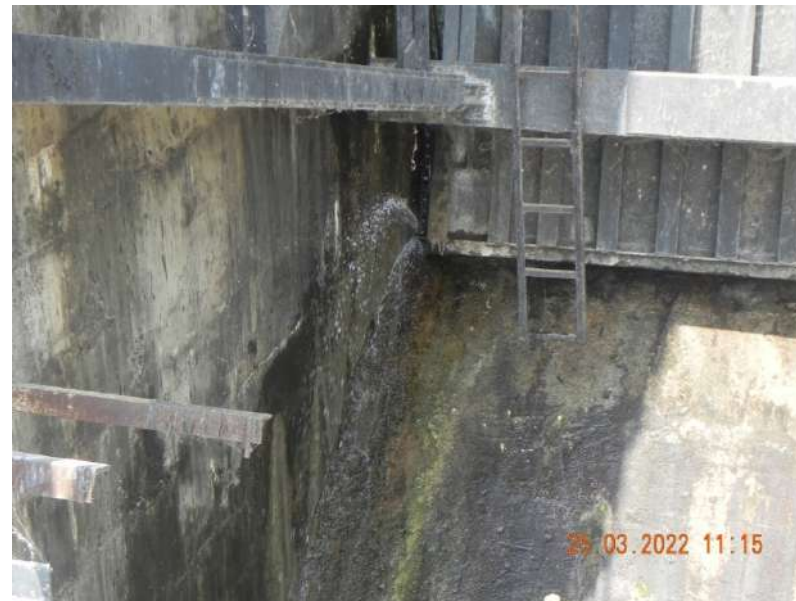
**Snapshot -2**  
**Girna Dam (Class II)**  
**Tal- Nandgaon, Dist- Nashik**  
**Date of inspection:25/03/2022**  
**Leakage through pier near gate is observed.**
