Government of Maharashtra
Water Resources Department

Annual Dam Health Status Report
2020-21
(Marathwada Region)

Superintending Engineer
Dam Safety Organisation
Nashik

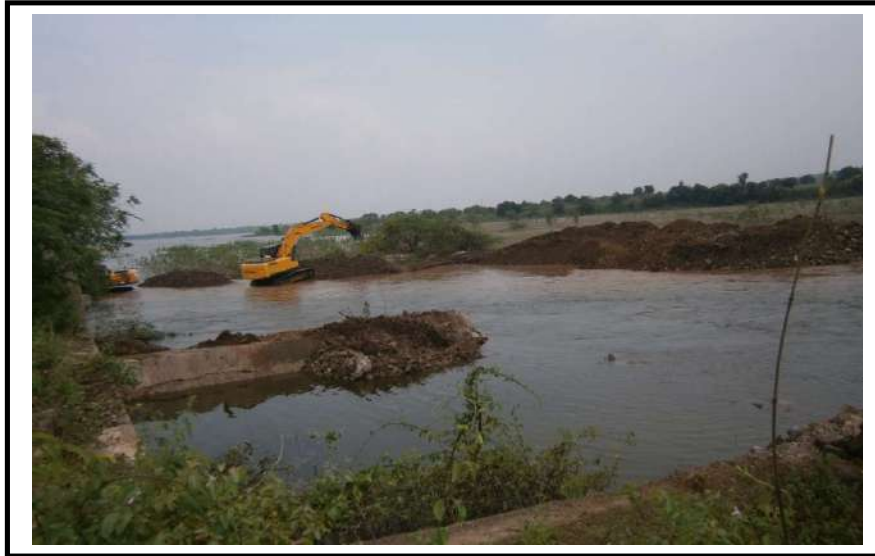
Snapshot -1

Khandeshwar Dam (Class-II)
Taluka - Bhoom Dist - Osmanabad
Date of Inspection – 1/10/2020
Waste weir bar severe damaged needs to be reconstructed (B7)

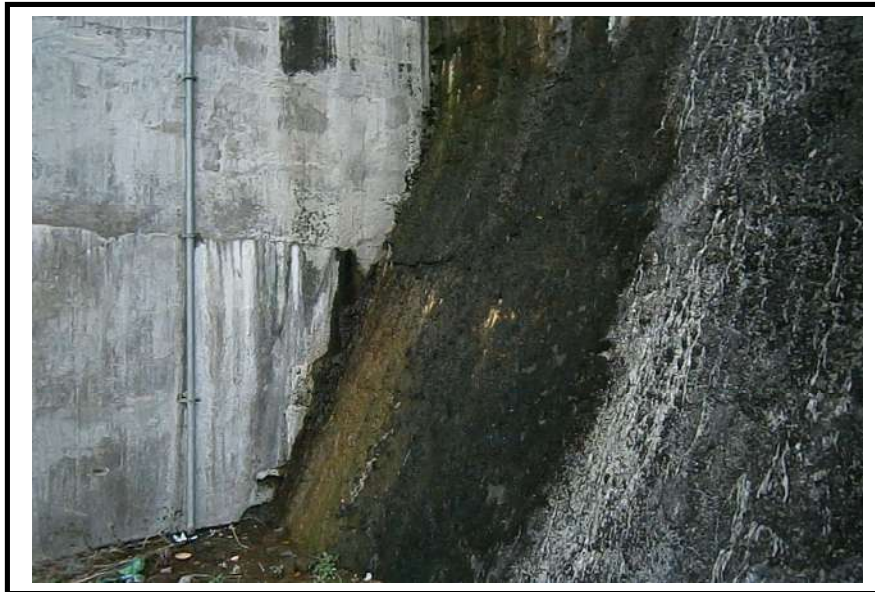
Snapshot- 2

Shivna Takli Dam (Class-I)
Taluka – Kannad Dist - Aurangabad
Date of Inspection – 09/07/2019
Sweating is seen on spillway. (A11)
