DSO/DSD1/KONKAN/HSR2019/ 214, Date:- 21.05.2020

Government of Maharashtra Water Resources Department

Annual Consolidated Health Status Report of Identified Large Dams in Kokan Region (Year 2019-20)

Superintending Engineer, Dam Safety Organization, CDO Building Dindori Road, Nashik- 4

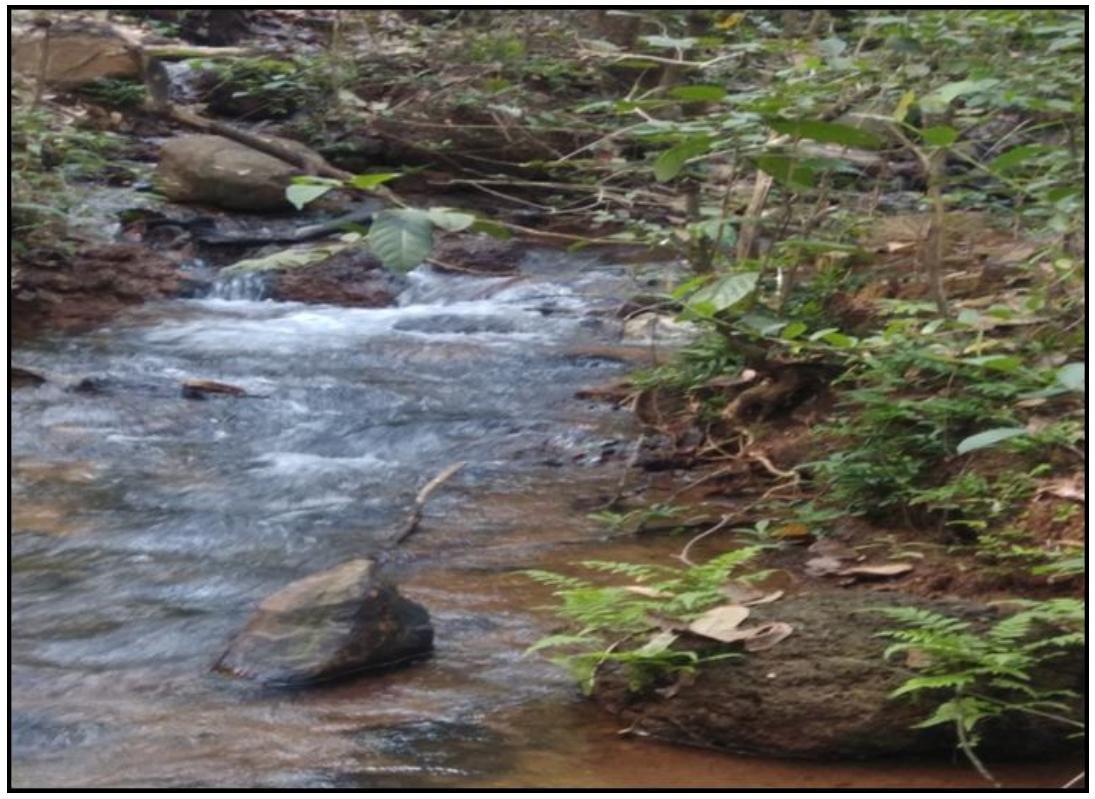
Photo -1 Otav dam (Class-I) Dist - Sindhudurg Deficiency: Major leakages on nearly about 300m d/s of saddle dam from natural ground. Date of Inspection - 19.12.2019.

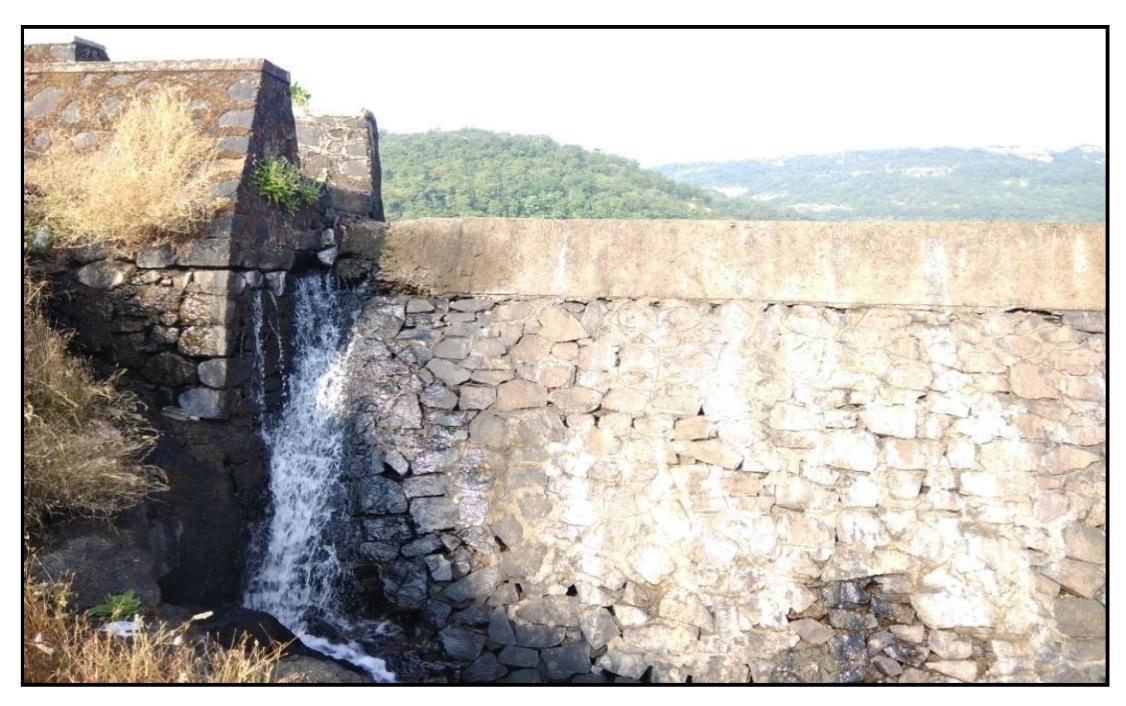
Photo - 2 Kondgaon dam (Class-II) Dist - Raigad Deficiency: Leakage through the w.w.bar & damaged U.C.R masonry Date of Inspection - 28.11.2019.

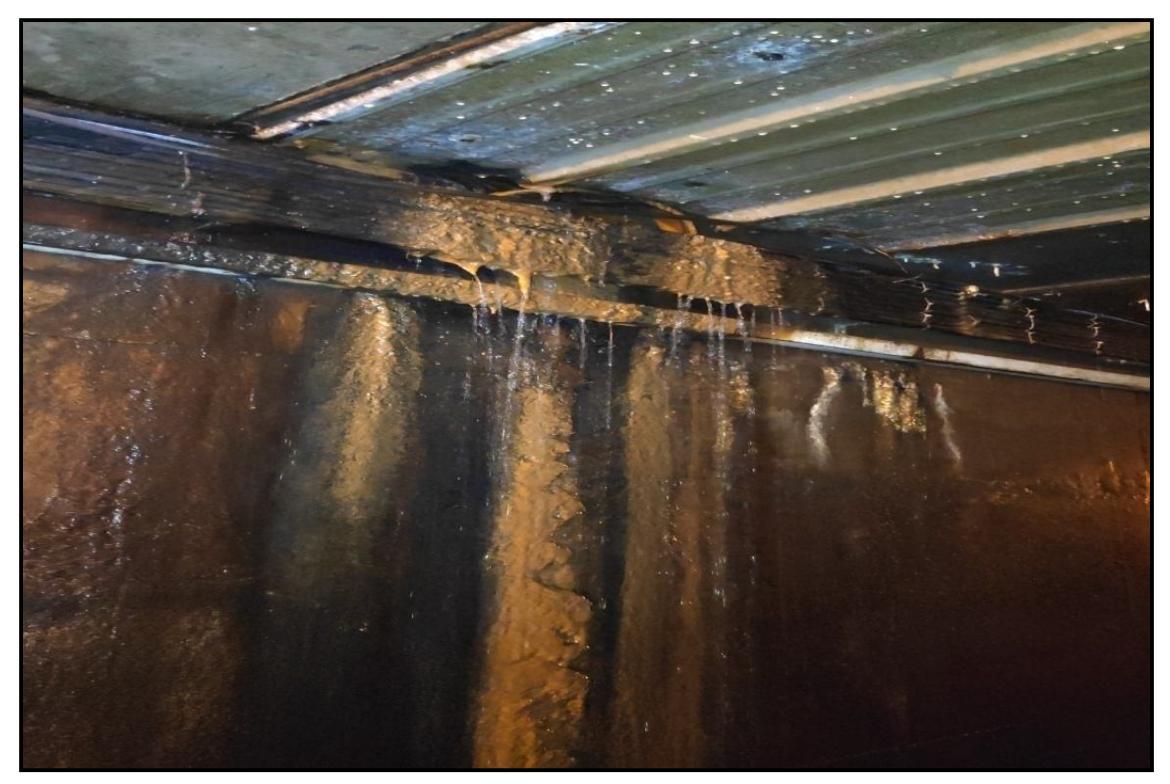
Photo - 3 Middle Vaitarna Dam (Class-I) Dist - Thane Deficiency- Considerable leakage from top of foundation gallery near shaft no.9 Date of Inspection - 04/09/2019

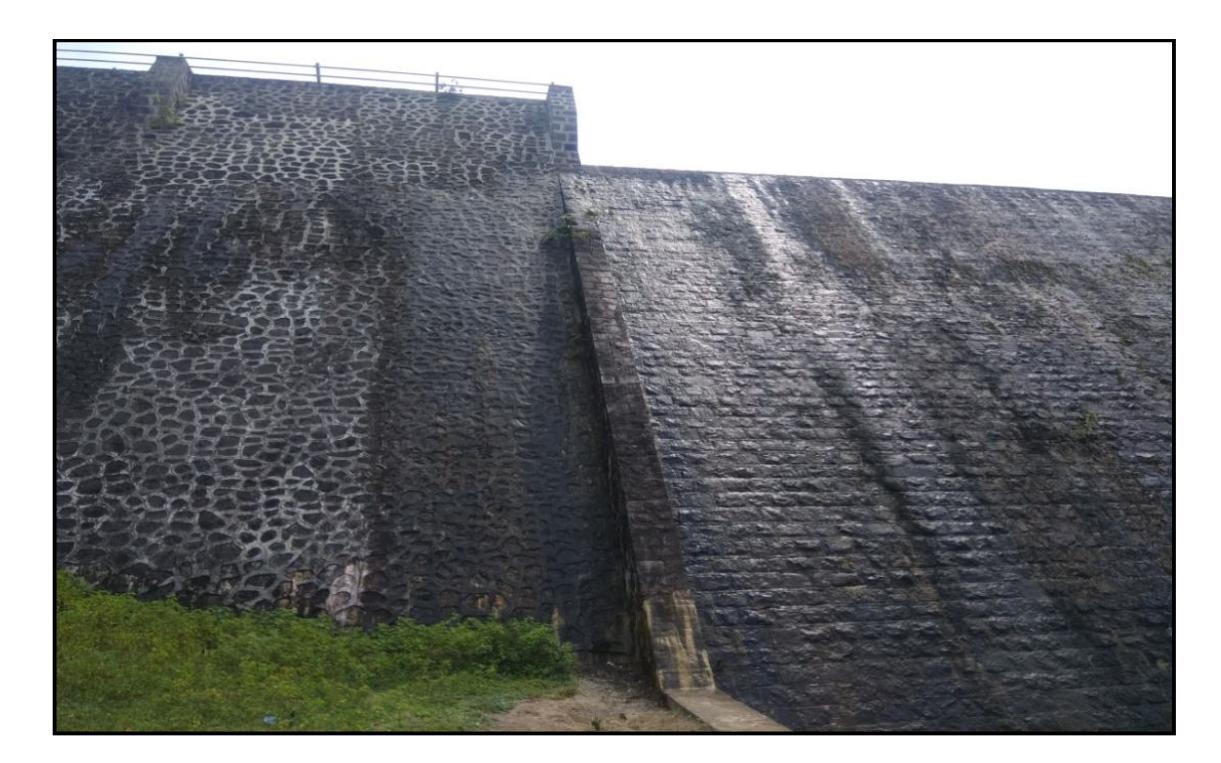
Photo - 4 Sakhare Dam (Class-II), Dist - Palghar Deficiency- Leakages on the downstream side of overflow section Date of Inspection - 11/10/2019
