Government of Maharashtra Water Resources Department

विषय :- धरण स्थिती अहवाल २०२१-२२ (पुणे प्रदेश)

Part-3: Dam Health Status Report of Pre & Post Monsoon 2021

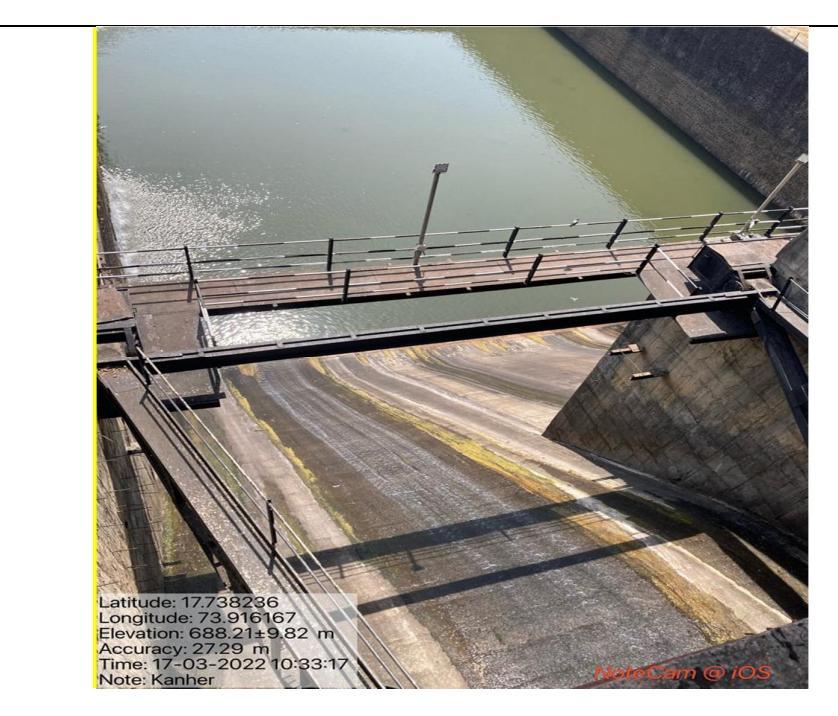
Snapshot-1

Kanher Dam (Class-I) Taluka –Satara Dist- Satara Date of Inspection – 17.3.2022 Minor leakages from Radial Gate No.1 is observed.
