# Government of Maharashtra Water Resources Department Annual Dam Health Status Report 2021-22 (Marathwada Region)

# विषय :- धरणं स्थिती अहवाल २०२१-२२ (मराठवाडा प्रदेश)

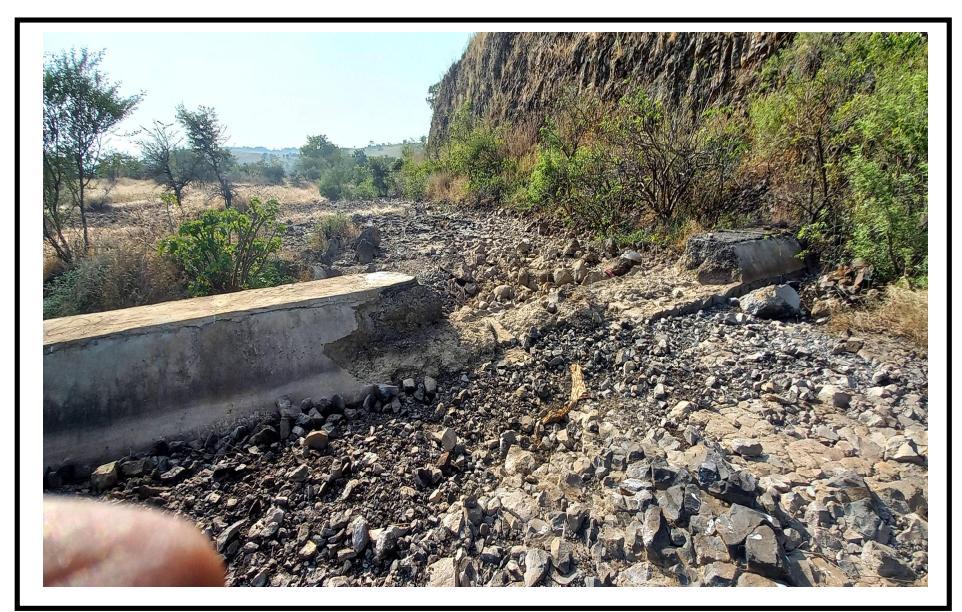
Snapshot -1

Wadgi Dam (Class-II) Taluka - Washi Dist - Osmanabad Date of Inspection – 09/08/2021 Waste weir bar severe damaged needs to be reconstructed (B7)

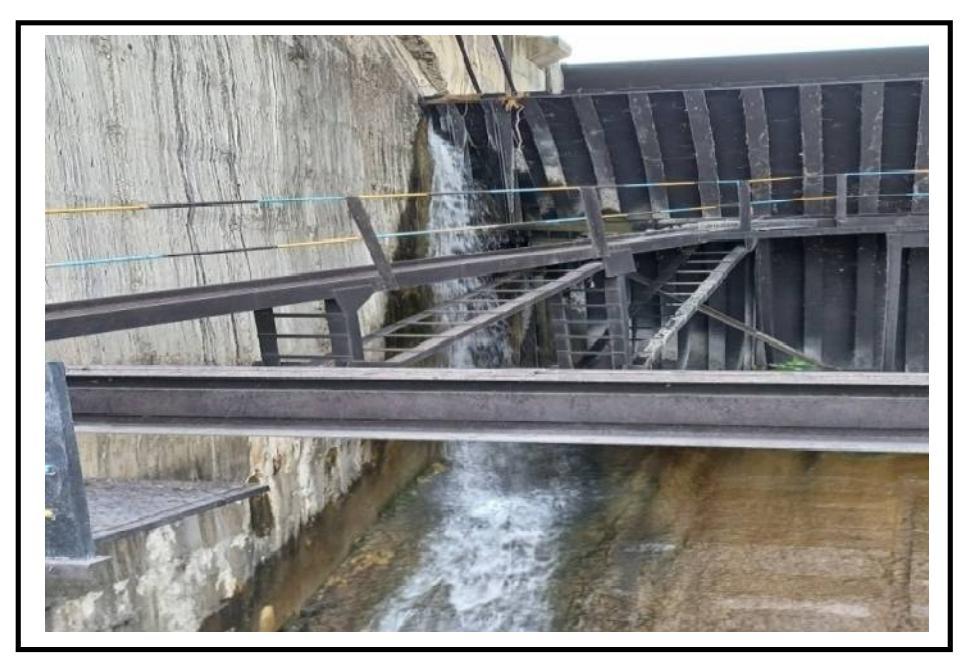
Snapshot- 2

Lower Terna Dam (Class-I) Taluka – Lohara Dist - Osmanabad Date of Inspection – 15/12/2021 Leakage through joint of pier anf NOF. (A11)
